An Engineering Geological Appraisal of the Leakage Problem in Dora-1 Earthen Dam, Tigray: Implications for its Stability

Gebremedhin Berhane^{1*} and Yowhans Birhanu²

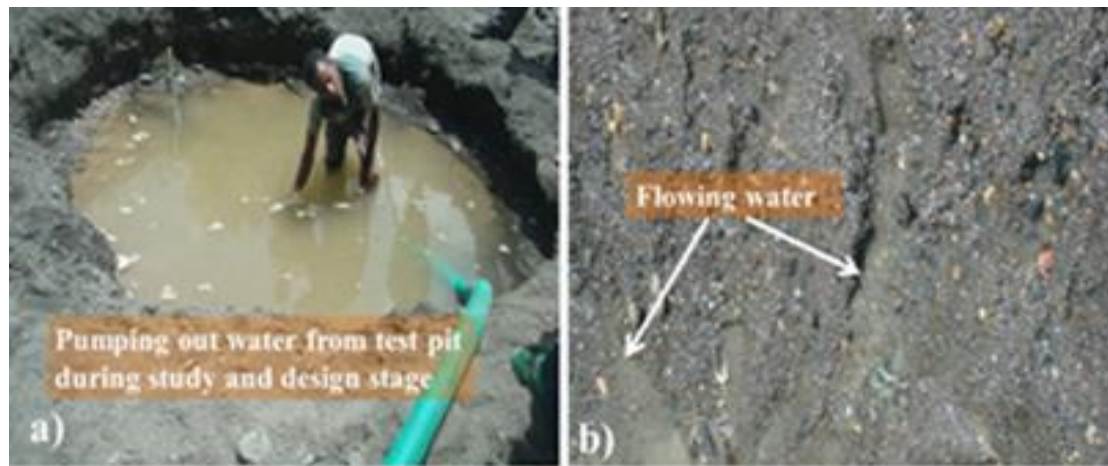
TWRB (2013), the deposit is about 6 to 7m thick, pervious, non-plastic and very loose. Subsurface water flow was observed at the test pits in the central foundation (Fig 3).

Figure 3. a) Subsurface water inflow into the test pit and pumping out. b) Foundation materials are very pervious and loose. Photographs are taken from TWRB (2013).

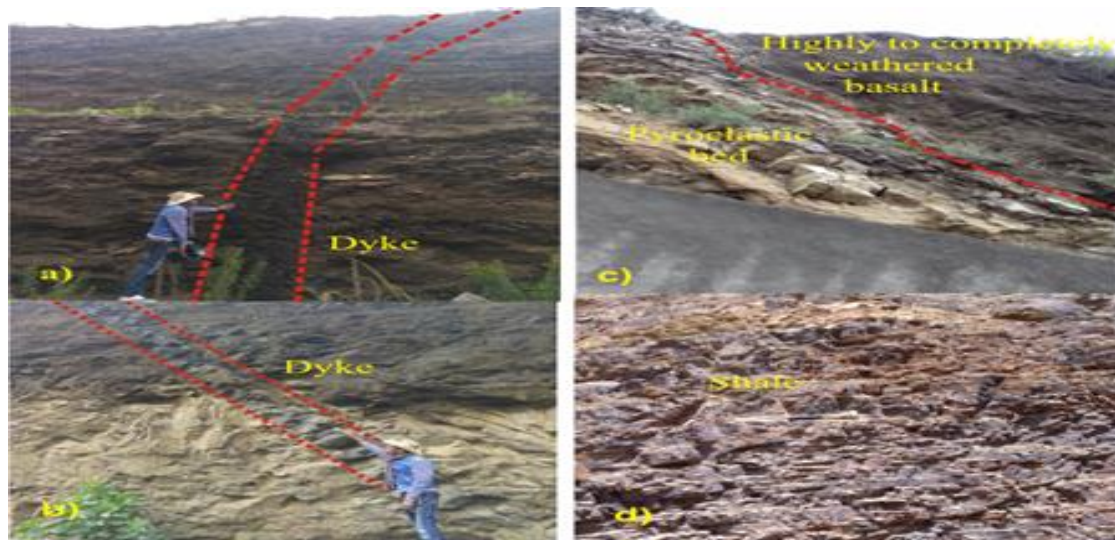
The right abutment is covered by a moderately to highly weathered and fractured basalt unit overlaid by residual soil. The spillway is located at the right abutment side. At the right side of the spillway excavation, moderately to highly weathered and fractured basalt rock unit is exposed. This unit is cross-cut by a dyke dipping at an angle of 54° to the upstream direction (Figs 4a & b). The geology at the left side of the excavation is not the same with the right side of the excavation. The left side comprises shale, moderately to highly weathered basalt and pyroclastic rock units stratified one over the other, and is dipping at an angle of 36° to the downstream direction (Figs 4c & d). Two dykes which have width of 0.8m each and spaced at 46m are exposed at the left side of the excavation. The dykes are massive and dipping to the upstream direction (Figs 4a & b), so they can act as barriers.

Figure 4. Rock units and structures exposed at the spillway, a) Dyke at the left of the spillway excavation, b) Highly to completely weathered basalt overlaying pyroclastic bed, c) Dyke at the right of the spillway excavation, d) Shale rock unit at left of the spillway excavation. All photographs taken by the second author in 2018.

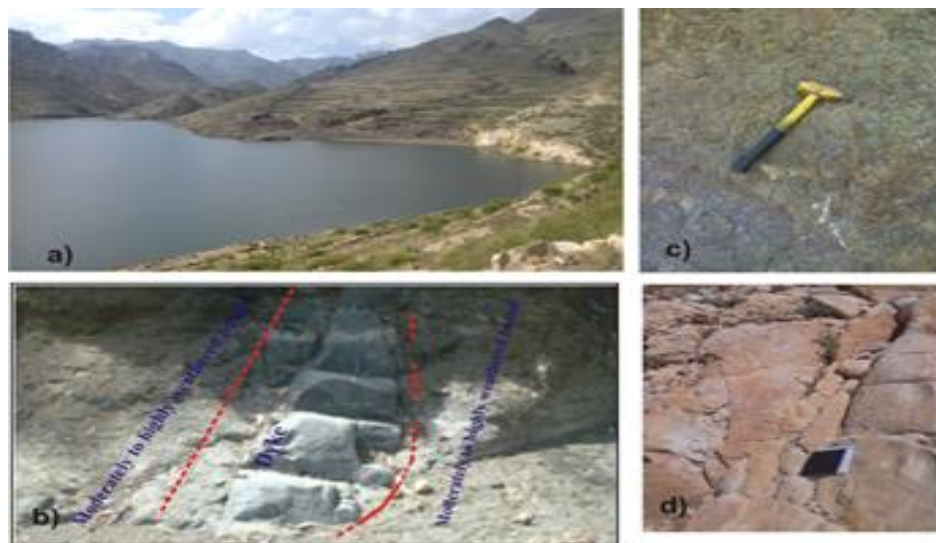
During the research work, the reservoir area was found to be partially filled by water (Fig 6a) and by sediment derived from the catchment. From the TWRB (2013) report, the reservoir area is mainly covered by alluvial deposit and residual soil. From the field observations, the alluvial deposit found at the downstream of the embankment is a mixture of sand and gravel with minor cobble to boulder sizes. In addition, a massive and late coming basaltic dyke is

observed at the river course in the reservoir area (Fig 6b) which extends towards the right abutment (TWRB, 2013). The basaltic unit trends toward the downstream part. This geological feature (contact between the dyke and surrounding basaltic rock) could be a possible leakage path. The basalt rock unit is moderately to highly weathered and the discontinuities are closely-spaced (Fig 6c). The rim of the reservoir is comprised of basalt and sandstone rock units. At the upstream side, the basalt is covered with residual soils and the sandstone unit is found exposed at the steep slope. The sandstone unit at the left abutment side was excavated at steep angle (nearly vertical). This can lead to sliding of rock blocks in to the reservoir during full impoundment. The sandstone unit is slightly weathered and is characterized by the presence of moderately-spaced discontinuities (Fig 6d). Simplified engineering geological map of the dam site and reservoir area is depicted in figure 7.

Figure 6. a) Over view of the rim of the reservoir, b) Basaltic dyke at the upstream river course of the reservoir (photograph taken and modified from TWRB (2013), c) moderately to highly weathered basalt at the rim of the reservoir, and d) Fractured sandstone unit at the rim of the reservoir. All photographs except b taken by the second author in 2018.

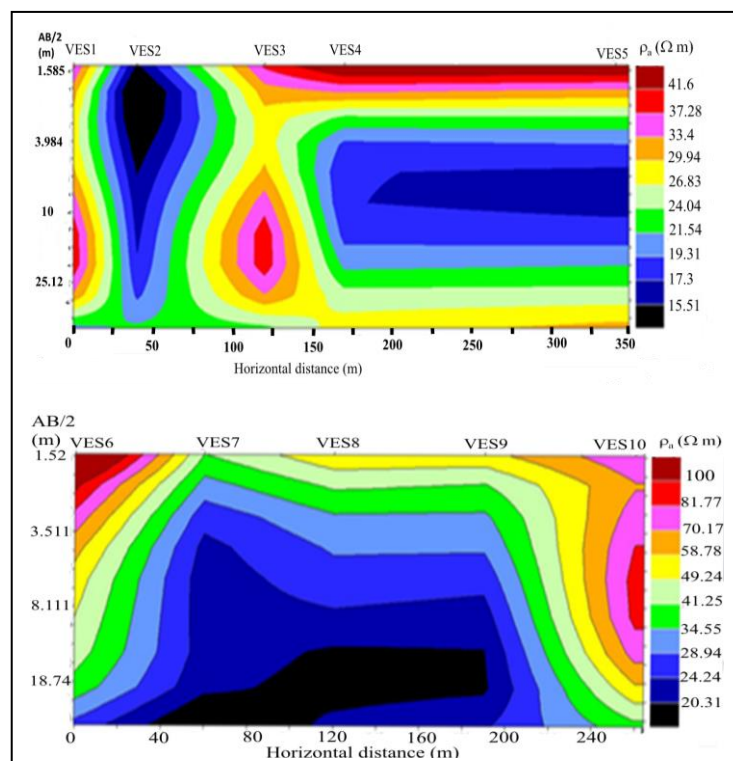
The survey for the pseudo-section (Fig 8) was conducted along the center of the dam crest. The center of the dam crest is the core material. The resistivity variation detected within the single material (core material) could be interpreted as the result of presence of defects, compaction difference, and moisture variations. The relatively low resistivity value ($<19.31 \Omega\text{m}$) found at a horizontal distance of 25 m infers to be the contact zone between the embankment body and the natural ground and the presence of geological defects. In the section starting from the horizontal distance of 150 m the resistivity decreases gradually from the top up to a depth of penetration by the current electrode spacing ($AB/2$) of 10 m, and again increases from $AB/2$ of 10 m up to $AB/2$ of 45 m. This variation in resistivity for a single zone (core material) indicates the presence of layering or stratification of the core fill material as a result of construction deficiencies (poor bondage between successive lift) and/or the presence of defects that could enhance leakage through the embankment body.

Figure 8. Apparent resistivity pseudo-sections (Ohm-meters) along VES1, VES2, VES3, VES4 and VES5 points at the dam crest, and VES6, VES7, VES8, VES9 and VES10 points at the dam berm starting from the left abutment to the direction of the right abutment.

The pseudo-section (Fig 8) is constructed from the sounding points that lie along the dam berm. The height of the berm is 24 m from the general foundation level. The pseudo-section shows a variation in resistivity of the embankment fill material with space and depth. Portion of the embankment starting from the left abutment up to a horizontal distance of 200 m shows a relatively low resistivity value (Fig 8). This low resistivity value could be the result of moisture due to the leakage, compaction deficiencies and lack of treatment of the foundation. This interpretation was confirmed by field observations where the outer portion of this section (the downstream shell material) was found to be wet and dripping (Fig 9).

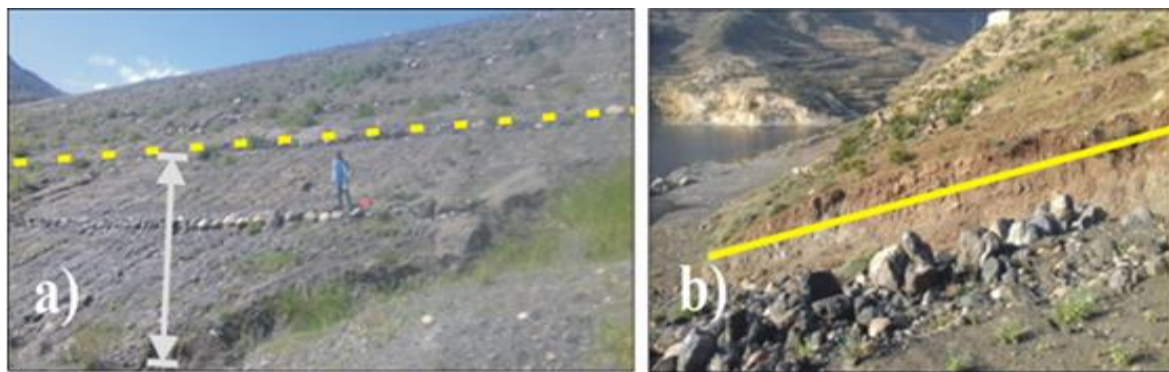
Figure 9. a) Field photo illustrates the wet portion of the embankment body (double arrow); b) Field photograph showing the contact between the basalt and sandstone units at the left abutment. Solid line shows the trend of the contact. Part of the reservoir (water) is visible in upper left side of the photograph. Photographs were taken by the second author in 2018.

Leakage is severed problem at this project to the extent that water is leaking directly through the embankment body. Portion of the embankment at the downstream face up to a height of 20 m was found to be saturated and wet (swampy) when the reservoir water level was at around 25 m. When the reservoir level was dropped the extent of the wet area was also dropped. Generally, as observed in the field the height of wet portion of the embankment varies with the fluctuation of the reservoir water level. Such phenomenon and observations are clear indications that the safety of the embankment is under question. The danger signs of

Dora-1 based on the U.S. Society on Dams (2011) guidelines are listed in table 2. In addition, field photographs that show the danger signs are presented in figures 9 and 11.

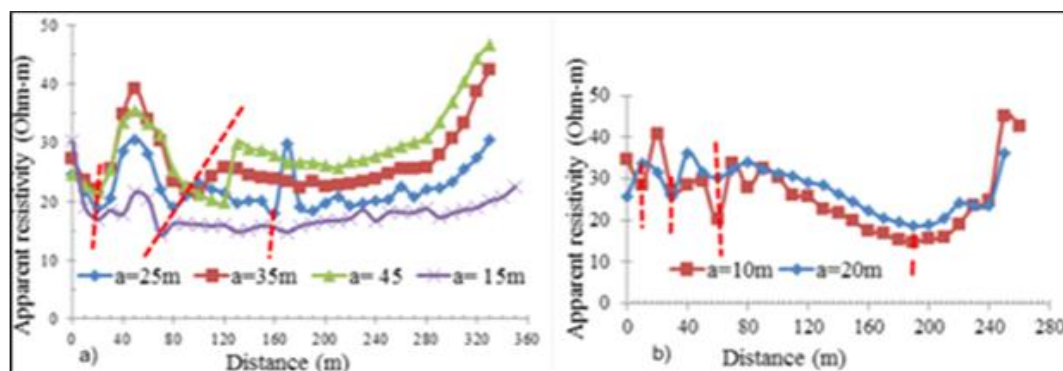
Figure 10. Graphical plot of the electrical resistivity profiling a) along the dam crest (profile one) and b) along the dam berm (profile two). The broken lines indicate interpreted as geological defects and variation in degree of compaction during construction.

According to Kirsch (2009) as cited in Berhane et al. (2016b) the presence of fracture zones and the degree of saturation of the ground can be determined using electrical resistivity profiling. As indicated in figure 10a, the resistivity varies laterally along the dam crest. This variation in resistivity was inferred as presence of geologic features favorable for leakage. The low resistivity value at around 20 m distance was interpreted as a result of the contact zone between the embankment and the natural ground. Low resistivity values at distances 60-80 and 160 m were interpreted as a result of geologic defects, variations in degree of saturation or the result of less (improper) compaction during the construction time.

The electrical resistivity profiling along the dam berm also shows lateral resistivity variations (Fig 10b). A relatively low resistivity values are observed at the horizontal distance of 10, 30, 60, and 80ms indicated by broken line (Fig 10). The low resistivity at the horizontal distance 10 m could be interpreted as a result of the contact zone, while those at 30, 60, and 80 m were interpreted as a result of defects/cracking, variation in degree of saturation due to improper compaction during the construction time. At a horizontal distances of 100–220 m the resistivity values decrease progressively. As observed during the field campaign, part of the embankment body below the dam berm was wet. This direct observation serves as a confirmation for the resistivity data interpretation. The apparent resistivity pseudo-section along the dam berm (Fig 8) and the graphical plot of electrical resistivity profiling along the dam berm (Fig 10b) show low resistivity values for this section of the dam body. This is the result of saturation of the embankment fill materials due to leaking water. The left abutment of the dam axis is founded on a sandstone and basalt units. The field photograph in (Fig 9b) shows the contact zone. The contact between the rock units crosses the dam axis. Discontinuities that intersect the dam axis, dipping toward downstream are the most promising features for leakage of water from reservoirs. So, the contact at left abutment of Dora-1 dam could be one contributing cause for the occurrence of leakage.

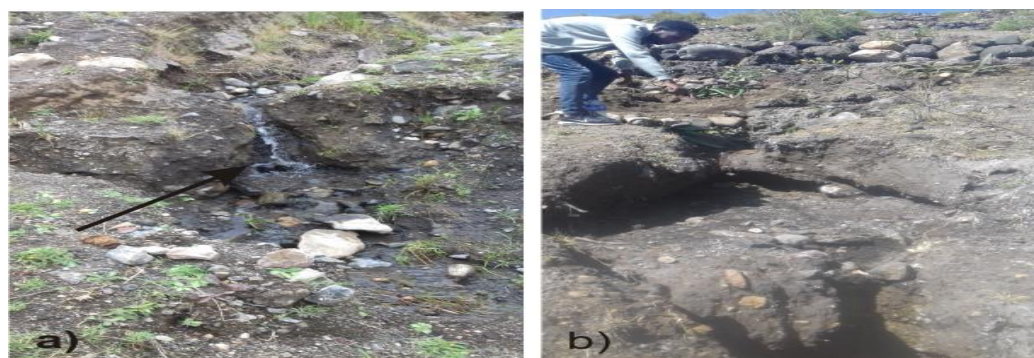
At Dora-1 dam, the leakage which is observed in the form of springs (Fig 11) was observed carrying fine soil particles. To check the probable source of the fine particles, dispersion test was conducted for the core materials. However, the laboratory test result showed non-dispersive character (Table 4). Therefore, the possible source of the fine materials could be the shell material and/or the moderately to highly weathered basalt found at the left abutment. The migration of fines via leaking water indicates poor performance of the filter material. Had it been good quality and fulfilled the filter criteria, migration of fine materials would not be observed. Cracks which are parallel to the dam axis (longitudinal) were also observed at the dam crest. The cracks are localized and have an opening up to 5mm wide.

Figure 11. Photographs showing leaking water (a) and erosion features (b) at the downstream face of the embankment. Arrow indicates leaking (flowing) water from the embankment body. Photographs were taken by the second author in 2018.

embankment to prevent excessive pore pressure and improve stability. A close flow-up and warning system during the reservoir filling toward its full level is recommended. Routine embankment slope protection measures (grassing-over, stone riprap, etc.) can prevent sheet and rill erosions at the down-and upstream slopes.

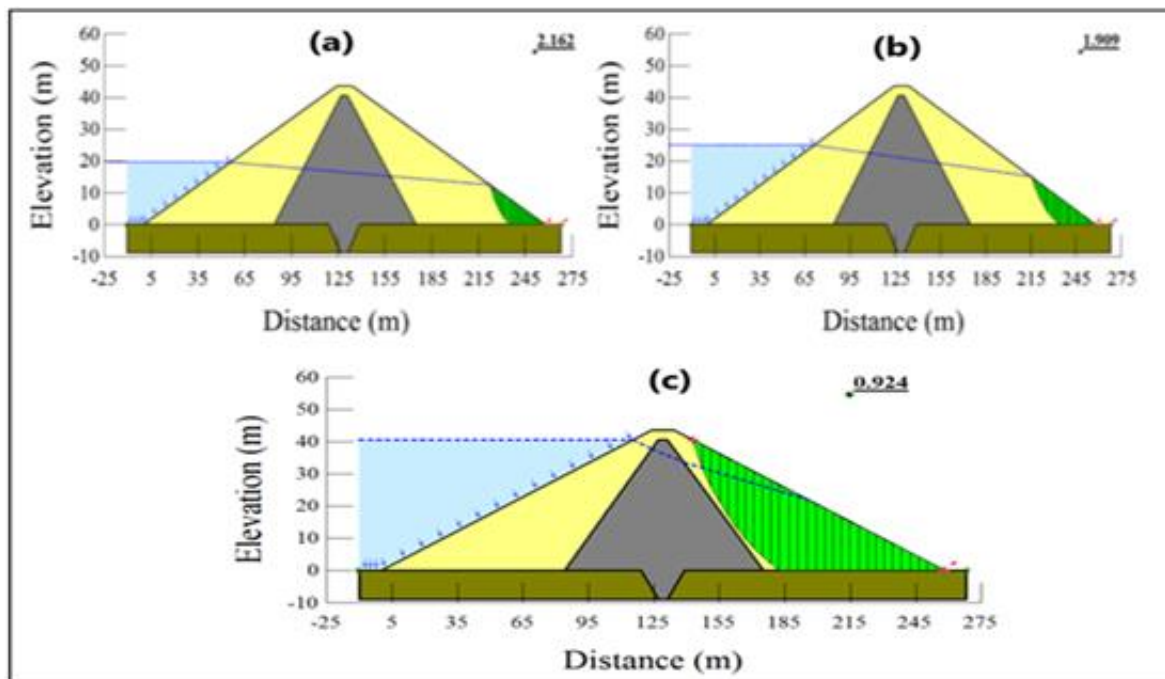
From the analysis results, the slip surfaces and the calculated factor of safety for the reservoir level of 25 m and 20 m are presented in figure 15, and for the full reservoir water (40.5m) in figure 14. The slope stability analysis was conducted using SLOPE/W model, one of the GeoStudio-2007 software products. The calculated factor of safety for the reservoir levels of 20 m and 25 m are 2.162 and 1.909 respectively. This shows stable condition of the embankment. But, the most critical condition of embankment occurs if the reservoir is fully impounded. The minimum factor of safety obtained at a full reservoir level is 0.835 (Fig 14). The dam is therefore, unstable at a full reservoir water level.

Figure 14. Stability analysis results for a reservoir level of (a) 20 m, (b) 25 m; and (c) for a full reservoir water level.

The engineering characteristics of the rocks/soils and geological structures at the dam foundation, reservoir area, and the abutments favor for the occurrences of leakage. Water is leaking along the contact between sandstone and moderately to highly weathered basalt units at the left abutment. The foundation and reservoir of the dam site is covered by gravelly sand and loose residual soils. Field observations and analysed data showed that part of the embankment in the downstream side is wet and saturated. With respect to the quality of the construction materials, some of the embankment materials were found unsuitable (filter with high percentage of fines, permeability of core and shell materials). The permeability of the core material falls under semi-previous category. The water absorption (above 2%) and the percentage of fines of the filter material don't satisfy the filter criteria. The presence of higher amount of fines can result clogging of the filters and drains and can result pore water pressure. The resistivity results showed strong variations for the same embankment material. This variation was interpreted as the presence of leakage triggering features, such as defects, layering of the embankment fill material due to compaction differences during construction. From the stability analysis conducted the factor of safety at a full reservoir level was 0.835. The dam is, therefore, unstable at a full reservoir water level. A layer of clean compacted gravelly sand/rock which can act as a drain is recommended at the downstream toe of the
