An Engineering Geological Appraisal of the Leakage Problem in Dora-1 Earthen Dam, Tigray: Implications for its Stability

Gebremedhin Berhane^{1*} and Yowhans Birhanu²

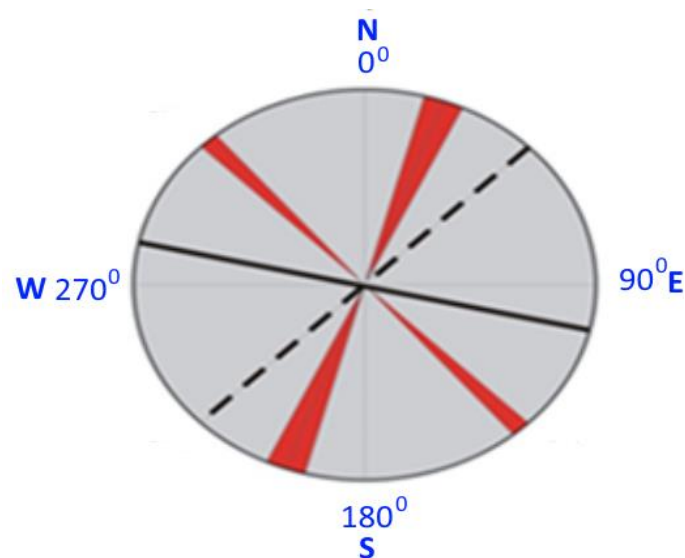
The right abutment is covered by a moderately to highly weathered and fractured basalt unit overlaid by residual soil. The spillway is located at the right abutment side. At the right side of the spillway excavation, moderately to highly weathered and fractured basalt rock unit is exposed. This unit is cross-cut by a dyke dipping at an angle of 54° to the upstream direction (Figs 4a & b). The geology at the left side of the excavation is not the same with the right side of the excavation. The left side comprises shale, moderately to highly weathered basalt and pyroclastic rock units stratified one over the other, and is dipping at an angle of 36° to the downstream direction (Figs 4c & d). Two dykes which have width of 0.8m each and spaced at 46m are exposed at the left side of the excavation. The dykes are massive and dipping to the upstream direction (Figs 4a & b), so they can act as barriers.

In left abutment basalt and sandstone units are exposed. The contact between the two units runs across the dam axis. Leaking water was observed during field observation along this area. This geologic feature is found to be favorable for water leakage from the reservoir. According to TWRB (2013), the recommended depth of excavation for the foundation was shallow, only 5m at the abutments and 9m at the central foundation. There was no concrete data regarding the actual construction or excavation depth at different part of the foundation. It was observed that the depth of weathering is beyond a depth of 5 m at the abutments and their surrounding. The strike of the dykes at the spillway and the geologic contact at the left abutment is presented in figure 5.

Figure 5. Rose diagram showing the strike of the 3 dykes (shaded plot) found at the spillway area and the geologic contact (solid line) at the left abutment in relation to the direction of the dam axis (broken line arrows pointing towards the center color of the circle).

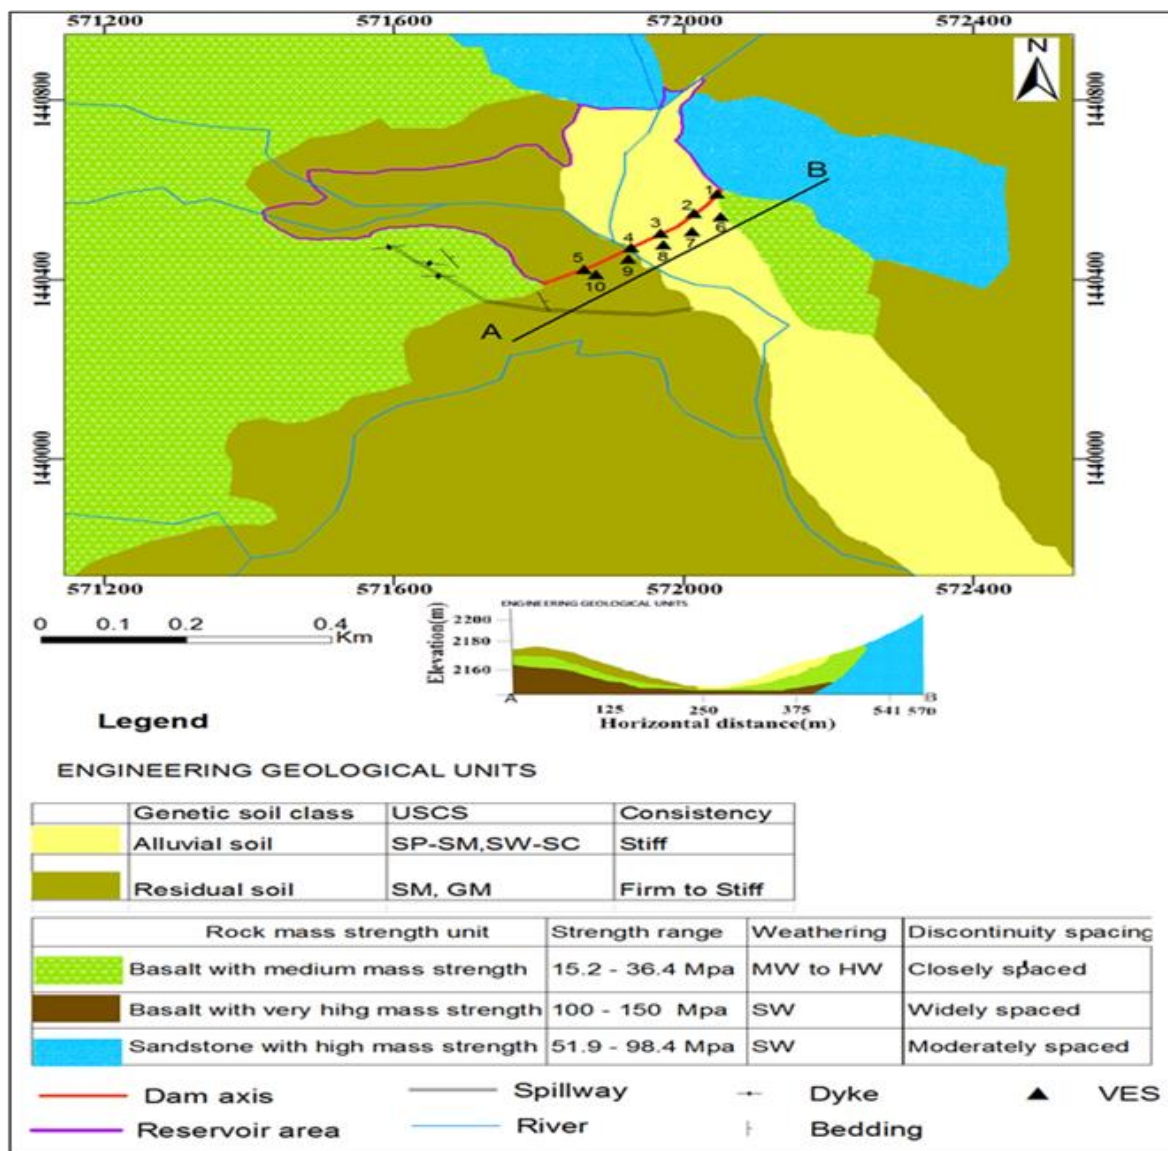
observed at the river course in the reservoir area (Fig 6b) which extends towards the right abutment (TWRB, 2013). The basaltic unit trends toward the downstream part. This geological feature (contact between the dyke and surrounding basaltic rock) could be a possible leakage path. The basalt rock unit is moderately to highly weathered and the discontinuities are closely-spaced (Fig 6c). The rim of the reservoir is comprised of basalt and sandstone rock units. At the upstream side, the basalt is covered with residual soils and the sandstone unit is found exposed at the steep slope. The sandstone unit at the left abutment side was excavated at steep angle (nearly vertical). This can lead to sliding of rock blocks in to the reservoir during full impoundment. The sandstone unit is slightly weathered and is characterized by the presence of moderately-spaced discontinuities (Fig 6d). Simplified engineering geological map of the dam site and reservoir area is depicted in figure 7.

Figure 7. Engineering geological map of Dora-1 dam reservoir area and its environs with cross-section along the direction of the dam axis.

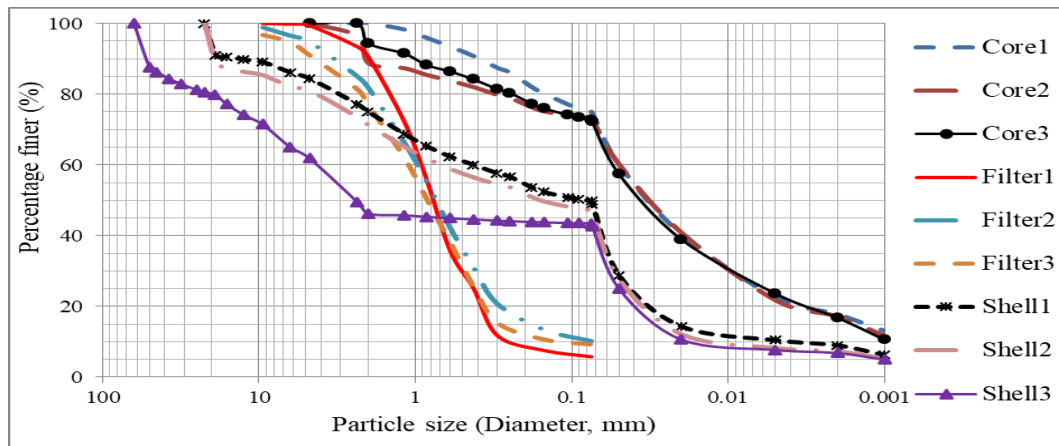
Figure 12. Grain size distribution curve of the embankment fill material.

The grain size analysis results for the filter, shell and core materials are presented in (Fig 12). The primary purpose of a filter material is to provide a safe drainage and prevent migration of fine particles from the protected zone. To achieve these purposes filter criteria is checked and fulfilled.

- ✓ The gradation curve of the filter material should be approximately parallel to the gradation curve of the protected soil (core material), especially in the finer range. This criterion is satisfied as can be seen in figure 12.
- ✓ Filters should not contain more than 5% fines and fines should be cohesionless to ensure that the filter is pervious and prevent cracking. This criterion is not satisfied. Because, the percentage of fines of the filter material ranges from 5.8 to 9.3%.
- ✓ The filter should not contain particles larger than 75 mm to minimize segregation. This criterion is satisfied.

Sample Shell1 and Shell2 of the shell material are classified as SM (Silty sand with gravel) and sample Shell3 is classified as GM (Silty gravel with sand). As it is portrayed in the grain size distribution curve (Fig 12), the shell material is consist of higher amount particles finer than #200 sieves (0.075mm) and it ranges from 43.5–49.3%. Obviously, the presence of higher amount of fine particles in the shell material can also lead to migration of fines from the shell material in to the filter material when water seeps in to the filter. This can result clogging of the filter. The purpose of shell material is to support the embankment (stability), and it should be pervious. But, actually the shell material used in constructing the dam has excess fines content, this can result clogging of the filter which in turn can result pore pressure and triggers leakage via the embankment and deteriorate its stability. The soil classification indicates that sample Core1 of the core material classified as CL and samples Core2 and Core3 as MH. As per USBR (1998), CL (Inorganic clays of low to medium plasticity) soils are ranked as 3rd based on the relative desirability of the soil as core material for embankment (suitable material). But, the MH (Sandy elastic silt) soils are characterized

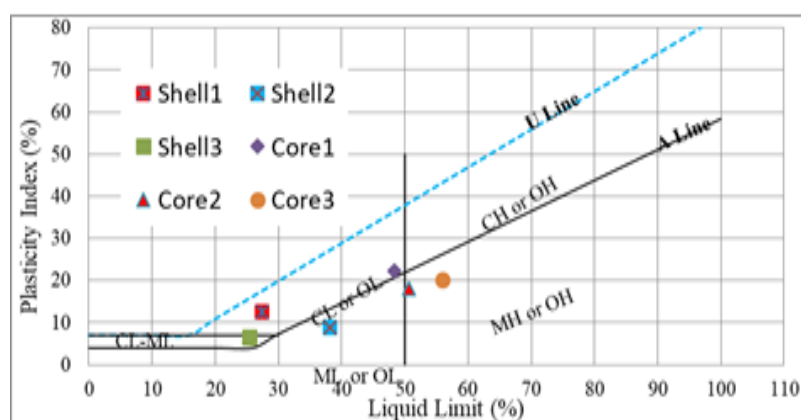
Figure 13. Classification of the core and shell materials using plasticity chart.

Atterberg limit tests were conducted for the core and shell materials show low liquid limit. Test results are summarised in table 5 and in the plasticity chart (Fig 13).
